Malidade Area

Borehole Rehabilitation

February 2015

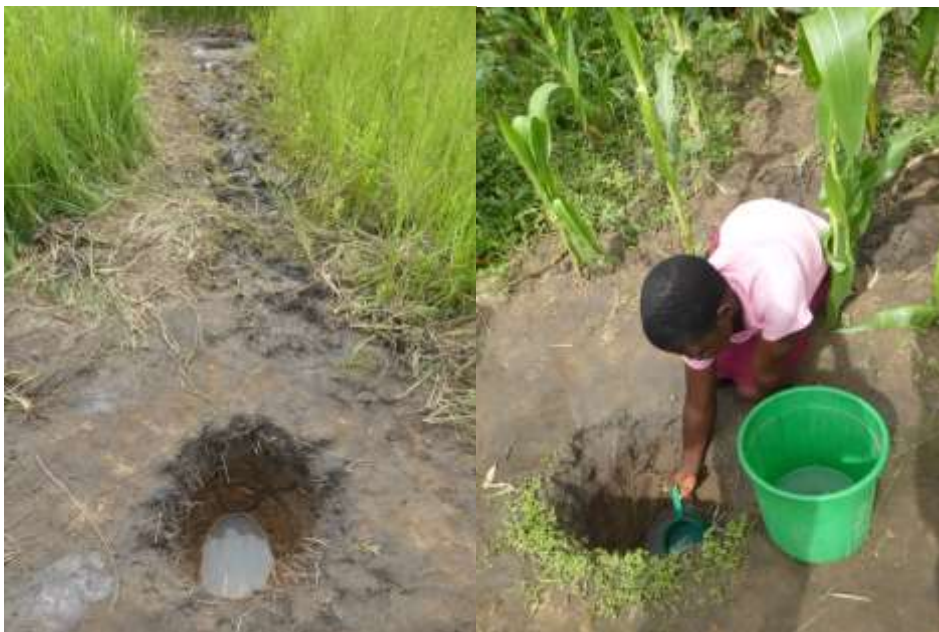
The aim of rehabilitating boreholes in the Malidade area is to reduce the use of open shallow wells (see Figure 1) and rivers as the alternative source of water. It is also to reduce the distance women and children have to walk to find and carry potable water (sometimes up to 2km).

Figure 1. Open Shallow wells at Site No. 9 Manoro.

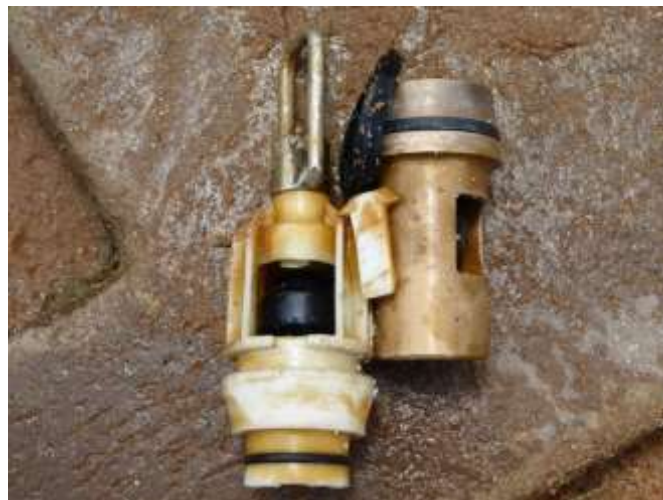
Rehabilitation- 20 and 21 February 2015. Seven rods were added to the existing 6 rods with the aim of increasing flow during the dry season. All of the pipes were replaced because they had been reconnected using fire (rather than using double sockets and solvent cement) and were not correctly aligned; this could explain the difficulty with pumping. The cylinder was replaced as the original cylinder did not hold water. It was blocked with a plunger seal and two foot valves (Figure 2).

Figure 2. Items blocking cylinder at 1. Jangavya

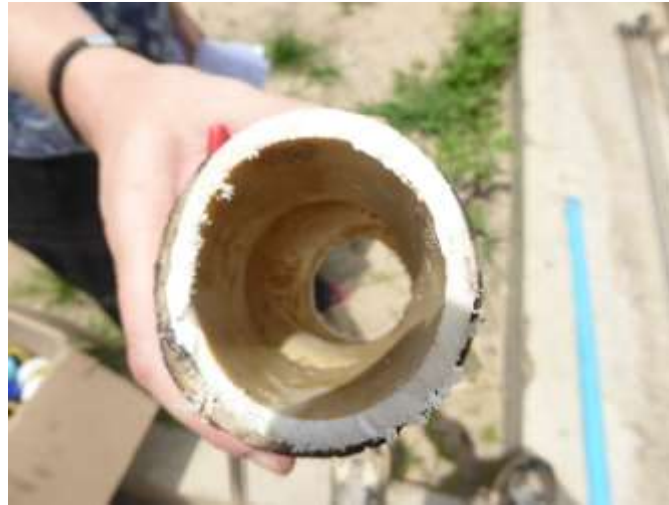
Rehabilitation - 13 February 2015. Following inspection it was found that the pump had failed due to misaligned pipes caused by reconnecting pipes using fire (Figure 3), also two damaged pipes had previously been removed. It was decided to reconnect the existing pipes and to restore the borehole to the original depth by adding two new pipes, with the aim of ensuring good flow throughout the year.

Figure 3. Misaligned pipes at 2. Jangavya.

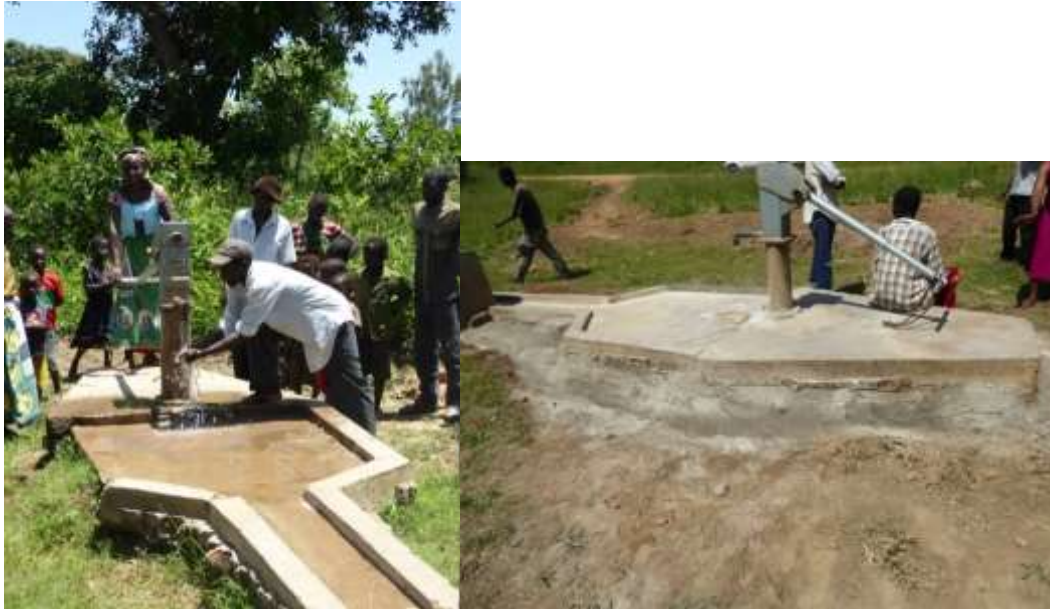
Assessment - 29 January 2015. **Non-functioning.** Installed in 2000 the pump had not been functioning for 5 months. The handle had broken (potentially as a result of an obstruction affecting the pumping action). The civil works were undermined due to erosion.

Figure 4. Before and after civil work improvement at 5. Kalanga.

Rehabilitation - 12 February 2015. Following inspection it was found that there were issues with the integrity of the pipework due to the age and previous repair work undertaken. The pump required an almost full replacement; nine new pipes were added to 3 existing pipes and 5 new rods to 7 existing rods. The cylinder was replaced as it did not hold water.

The committee contributed river sand and stone and completed the civil works (Figure 4).

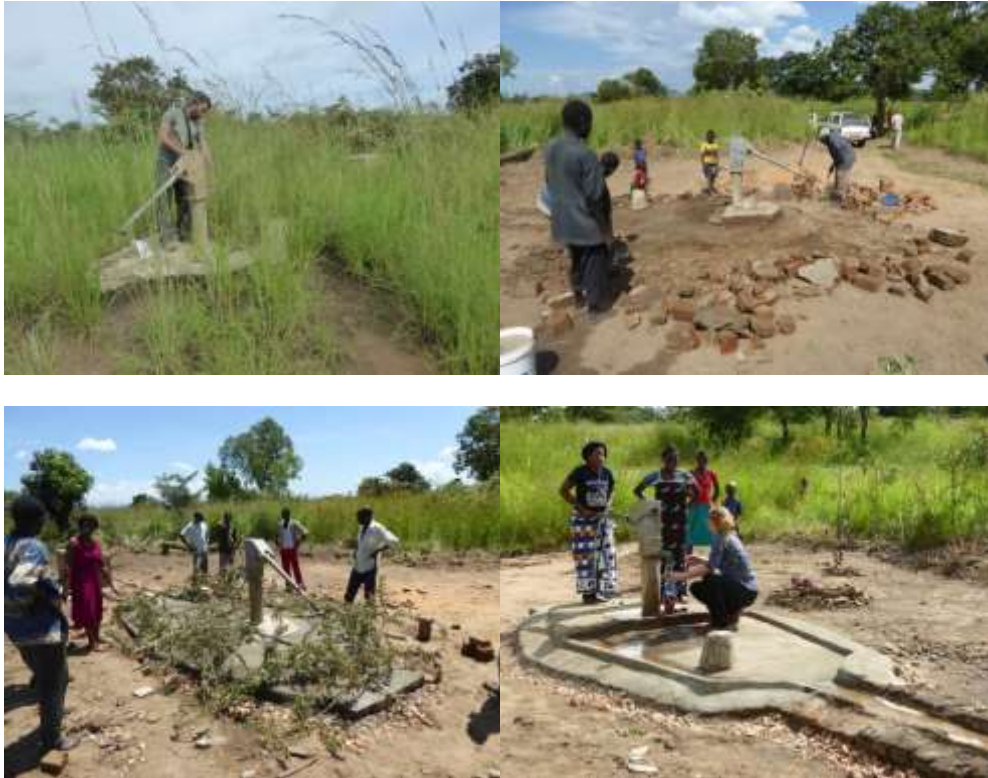
Rehabilitation - 12 February 2015. Following inspection it was found that there were issues with the pipework integrity and the cylinder did not hold water. The pump required an almost full replacement including pipework and cylinder; 7 new pipes were added to 5 existing pipes and 12 new rods were used.

Figure 5. Before and after civil work improvement at 4. Manoro

The committee provided sand, stone and bricks in order for the village head (a mason) to complete significant improvement to the civil works (Figure 5).

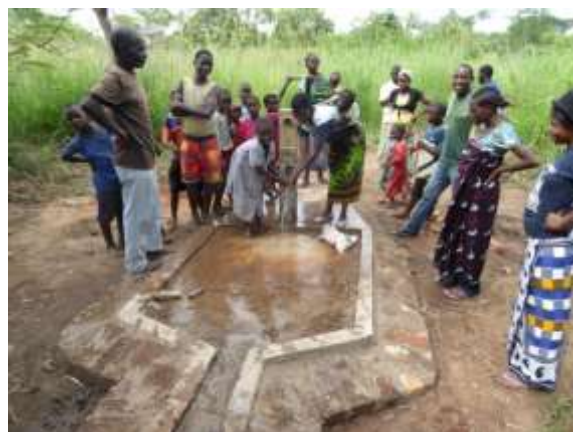
Rehabilitation- 19 February 2015. Following inspection it was found that the pump was blocked with debris, there were issues with the pipework integrity and the cylinder did not hold water. Six new pipes were added to 4 existing pipes 6 new rods were added to 4 existing rods and a new cylinder was installed.

Figure 6 Before and after civil work improvement at 7.Manoro

The committee contributed river sand and stone and completed the civil works.

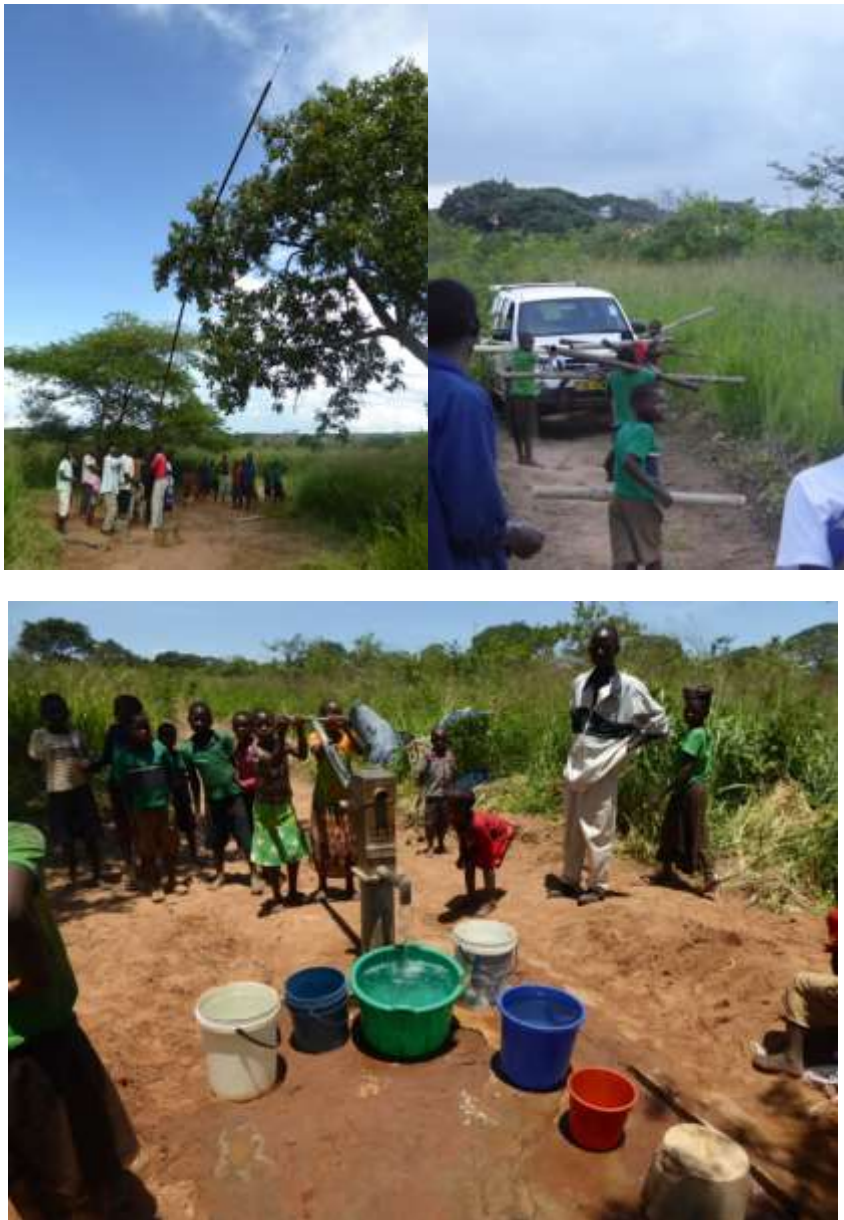
Rehabilitation -12 February 2015. Following inspection it was found that the pump was blocked with debris and the pipework integrity was also compromised. Five new rods were added to 7 existing rods and 10 new pipes were added to 2 existing pipes. A new cylinder was installed as the existing cylinder did not hold water.

Figure 7. Rehabilitation at 8. Manoro

The committee improved the civil works.

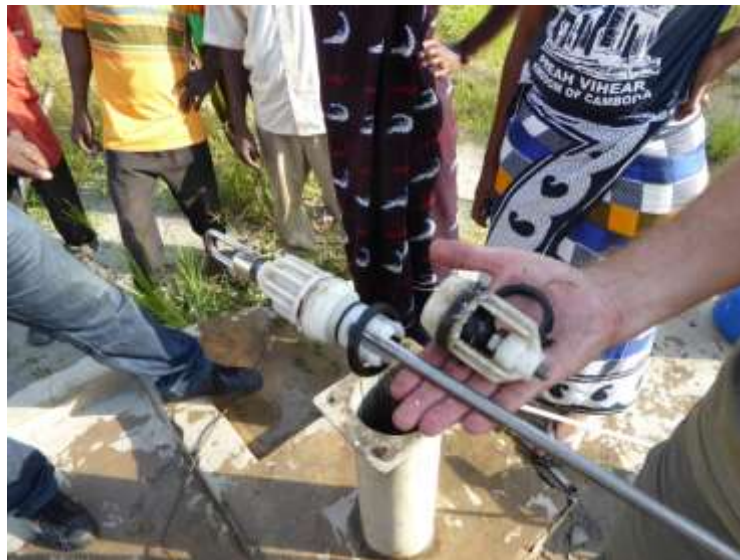
Rehabilitation - 19 February 2015. Following inspection it was found that the cylinder was blocked with an unattached plunger and seal and a foot valve to a plunger stick (Figure 8). All of the pipes were replaced because they had previously been reconnected using fire and were not correctly aligned. Fifteen new pipes were used and 3 rods were added to the existing 12 rods to ensure good flow throughout the year. During rehabilitation the village chief was present and commenced formation of a new water committee.

Figure 8. Parts blocking cylinder at 9. Manoro

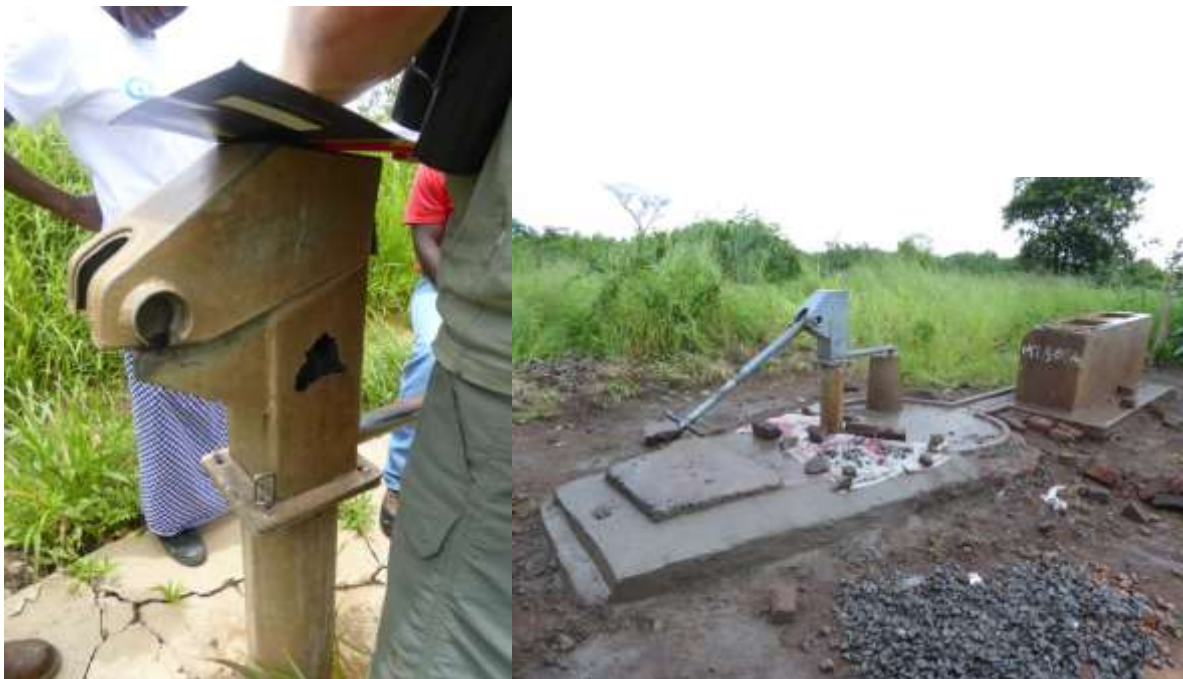
Assessment - 2 February 2015. **Non-functioning.** Installed in 1994 the borehole serves 70 households. It had not been functional for 12 months. Discussions with the local community revealed all the rods had been removed (reportedly stolen), also the pump head was damaged (Figure 10) and the pedestal corroded.

Figure 10 Damaged head and civil improvements at 15. Chibangalala

Rehabilitation - 18 February 2015. The pump required an almost full replacement including pipework, rods and cylinder; 9 new pipes were added and 9 new rods were used. The borehole had previously been partly filled with sand by the committee in an attempt to reduce salinity, and this is the reason for the relatively shallow depth of 29 metres.

The committee provided one rod and sourced sand, stone and bricks in order for a local mason to complete significant improvement to the civil works (Figure 10). They were advised to purchase a pump spanner and fishing tool for future maintenance.

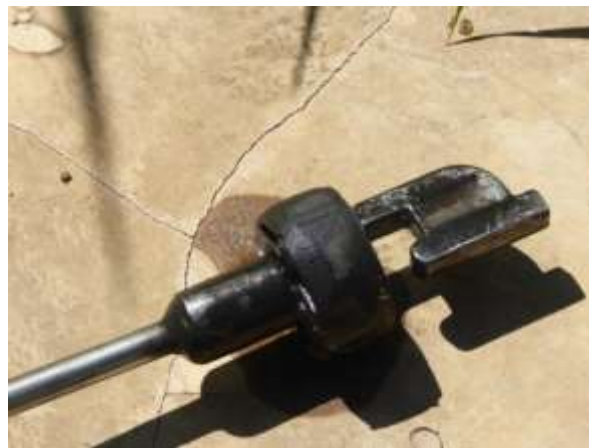
The water in this area is saline and some community members indicated they may continue to drink from open shallow wells even if a functional borehole was available. The salinity also causes increased corrosion of parts, especially rods (Figure 11).

Assessment - 2 February 2015. **Non-functioning**. Installed in 2007 the borehole serves 60 households and had not been functional for 12 months. Discussions with the local community revealed one rod had broken and three were corroded. The committee had been unable to fund replacements.

Figure 11. Black residue due to corrosion by saline water at 18. Kabira

Rehabilitation - 20 February 2015. Five rods were added to restore the borehole to 12 rods.

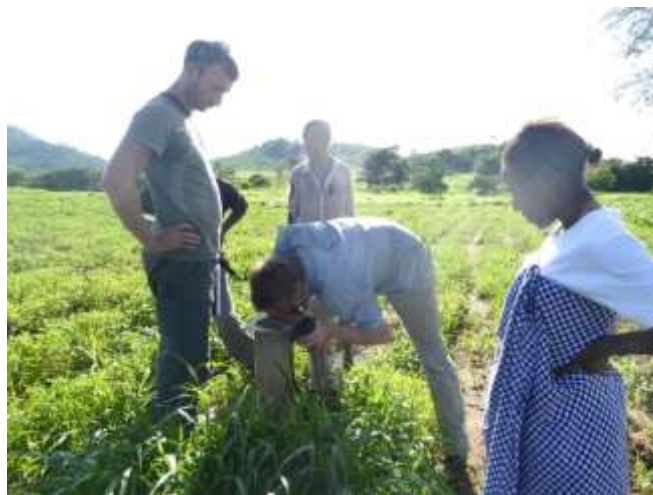
Assessment - 2 February 2015. **Non-functioning.** Beyond repair as the head, rods and handle had been removed (Figure 12) and the pump and blocked with soil.

Figure 12. Beyond repair- inspection of 20. Thunduwike
