Malidade Area

Borehole Rehabilitation

February 2015

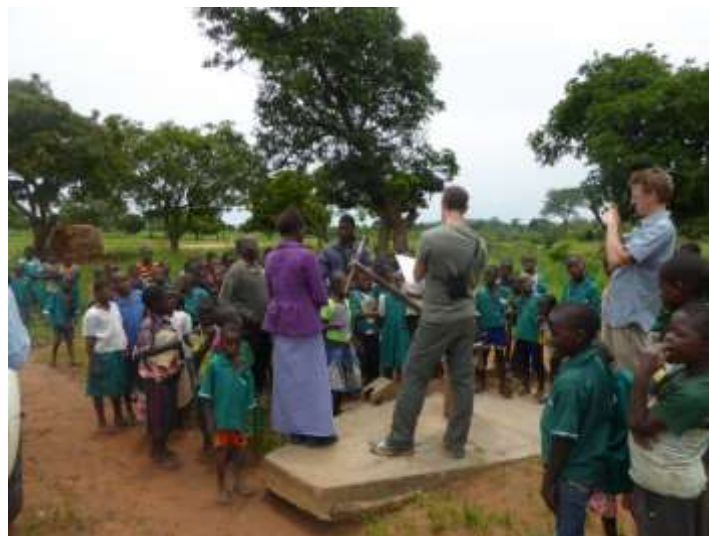
Assessment -2 February 2015. **Non-functioning.** Installed in 2003 the borehole serves a school (Figure 9) and community of 600 to 700 people. It had not been functional for 2 months. During this time classroom time was lost because school children and teachers had to travel a greater distance to access safe water. Some children attended other schools that had functional boreholes.

Figure 9. School children at 14. Chibangalala

Rehabilitation -11 February 2015. Following inspection it was found that the pipework integrity was compromised due to previous repairs. All 11 of the pipes were replaced and the borehole was restored to the original depth by adding 4 further new pipes and rods, with the aim of ensuring good flow throughout the year.
